# St. Peter dome in Rome (built 1590) Development of cracks (1742)

**VICOFORTE  
DESCRIPTION OF 1985  
STRENGTHENING WORKS**

**VICOFORTE  
RELIABILITY  
ASSESMENTS**

## **2. Evaluation and reduction of seismic risk**

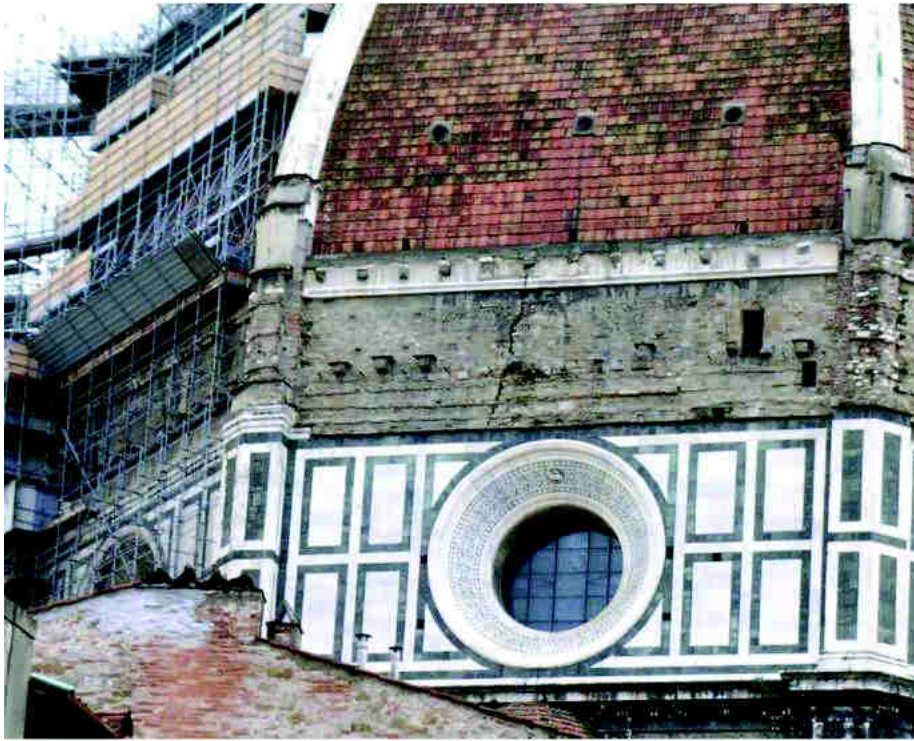
**NE main meridional crack**  
**External view**

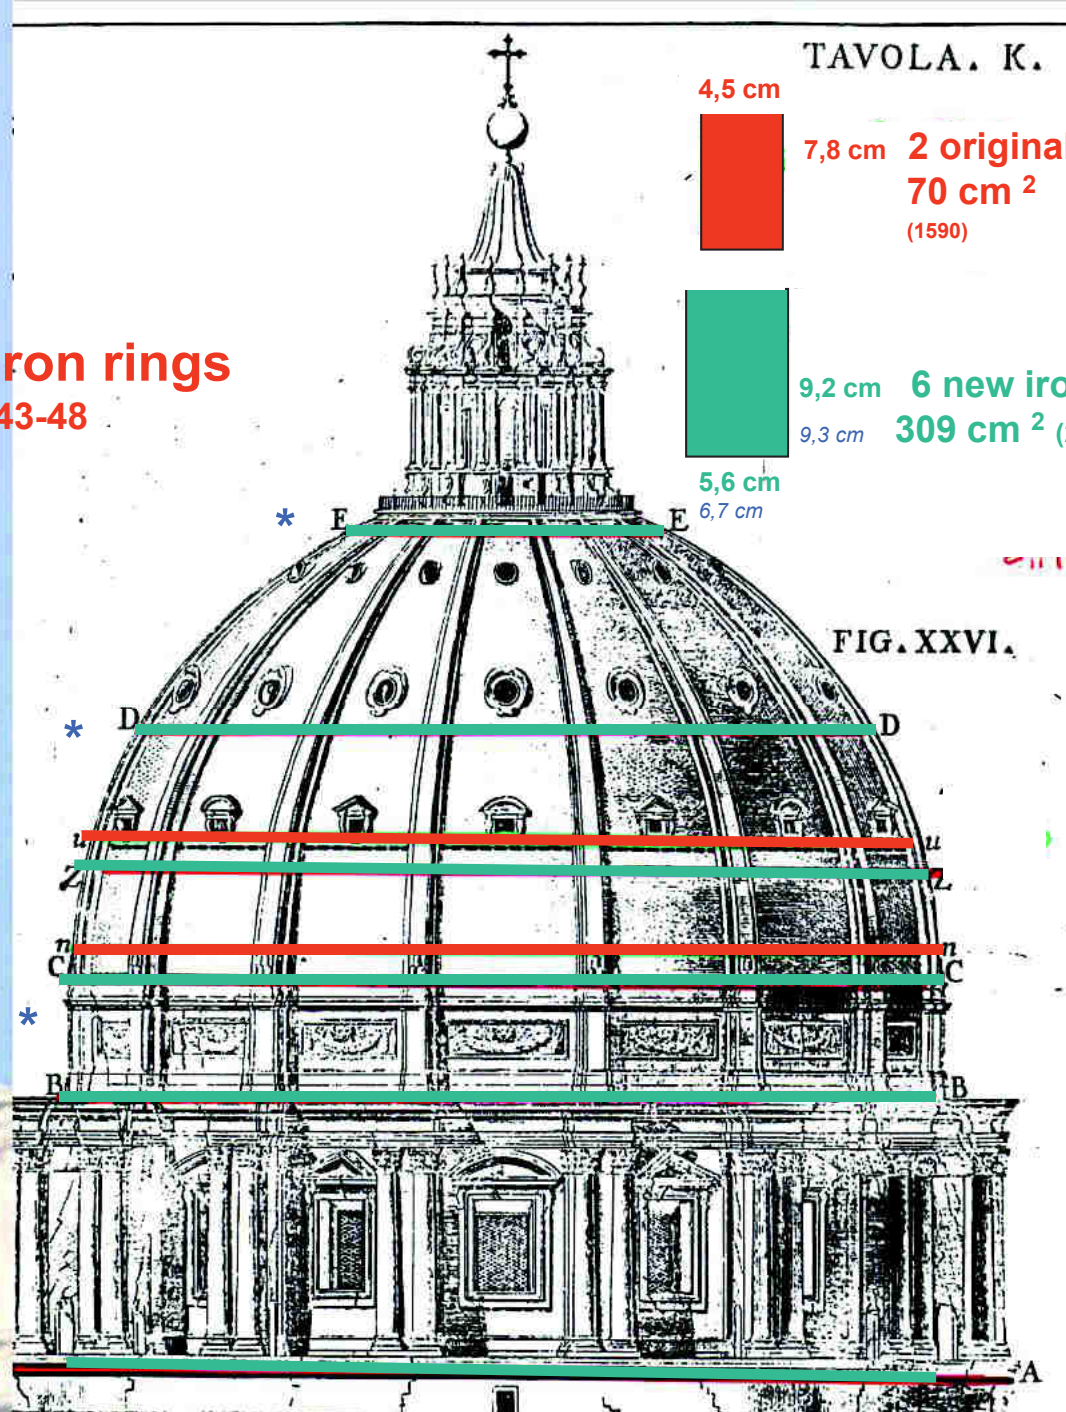
TAVOLA. K.

4,5 cm

7,8 cm **2 original iron rings**  
**70 cm<sup>2</sup>**  
 (1590)

9,2 cm **6 new iron rings**  
 9,3 cm **309 cm<sup>2</sup>** (210 cm<sup>2</sup> being active)

5,6 cm  
 6,7 cm

# Insertions of new iron rings

G. Poleni e L. Vanvitelli 1743-48

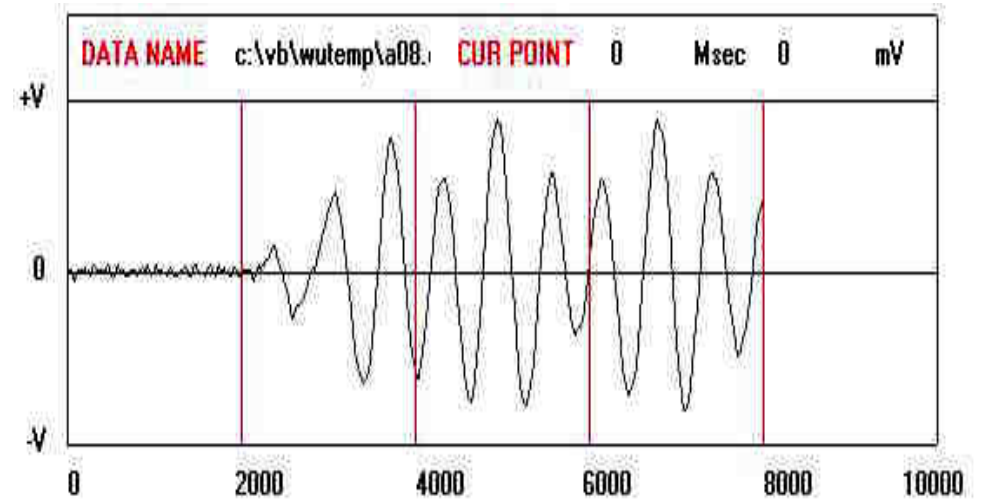
## Continuity checks by sonic testing

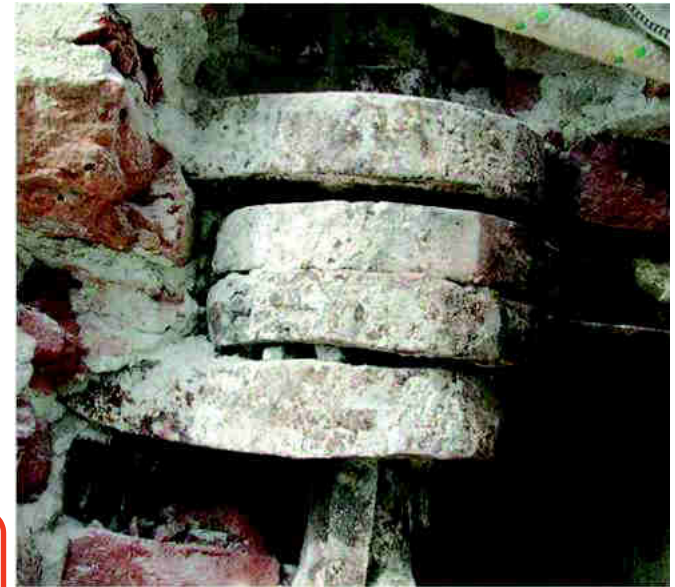
Chiavardatura a cunei contrapposti

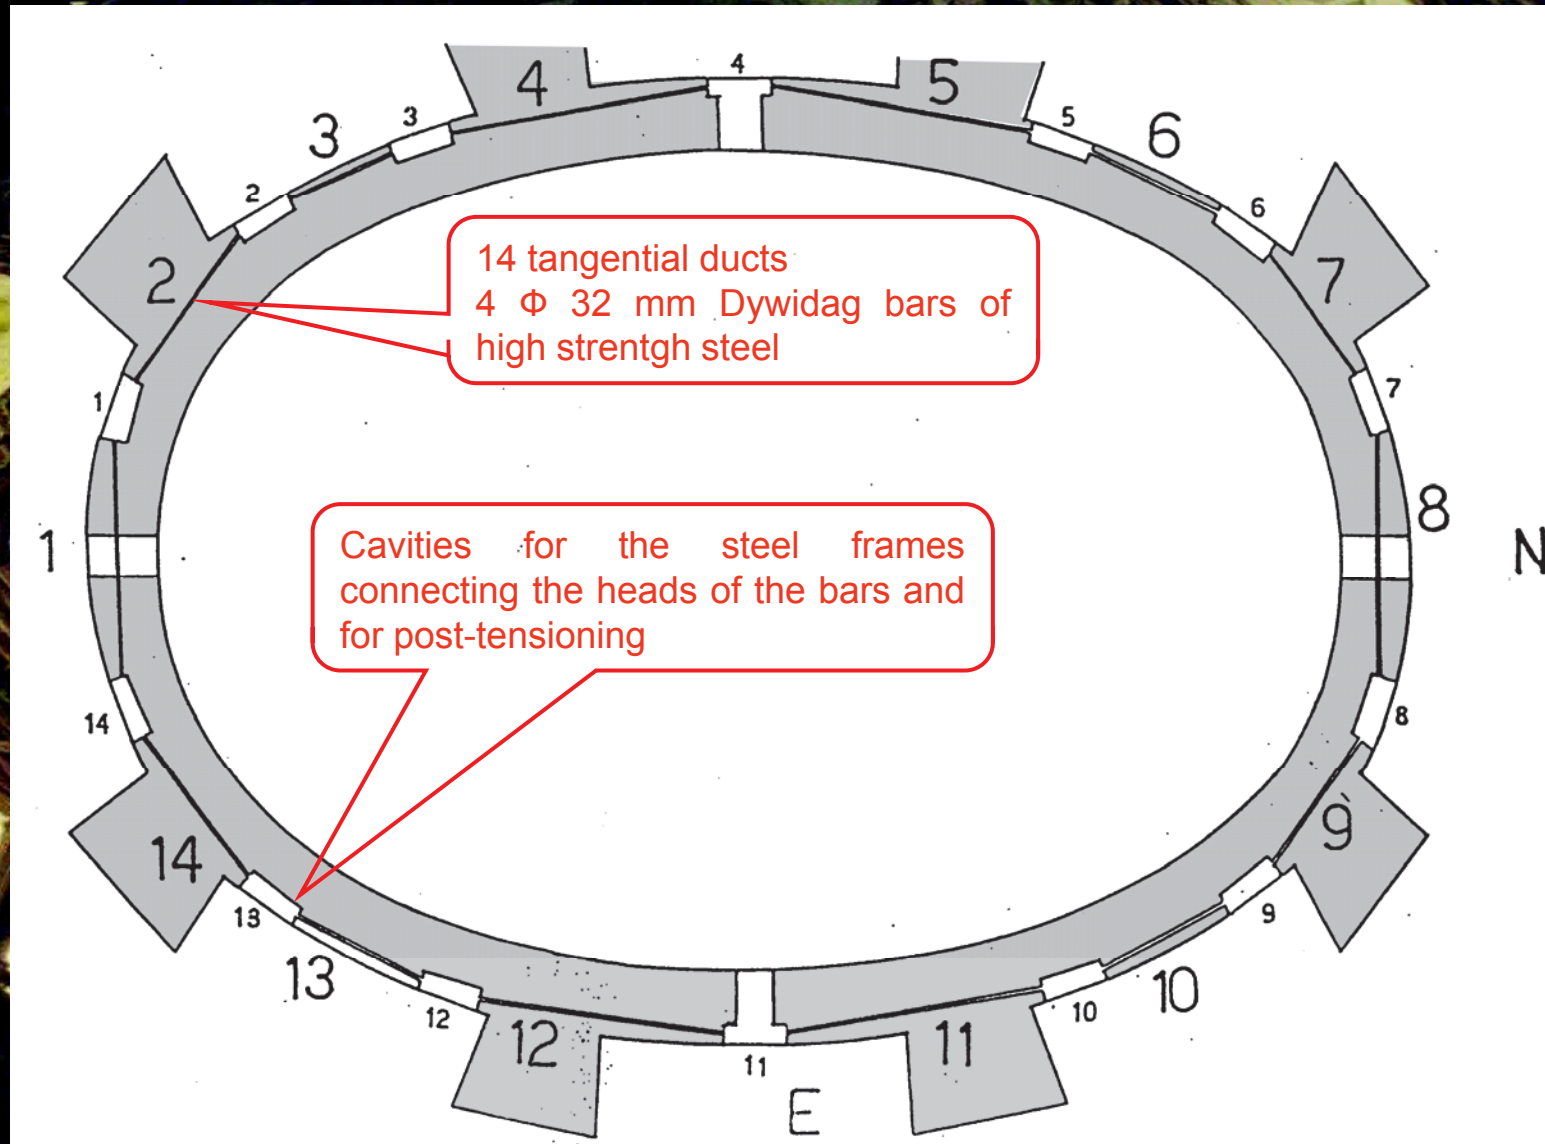
# Post-tensioning ring at the base of the dome (1985-87)

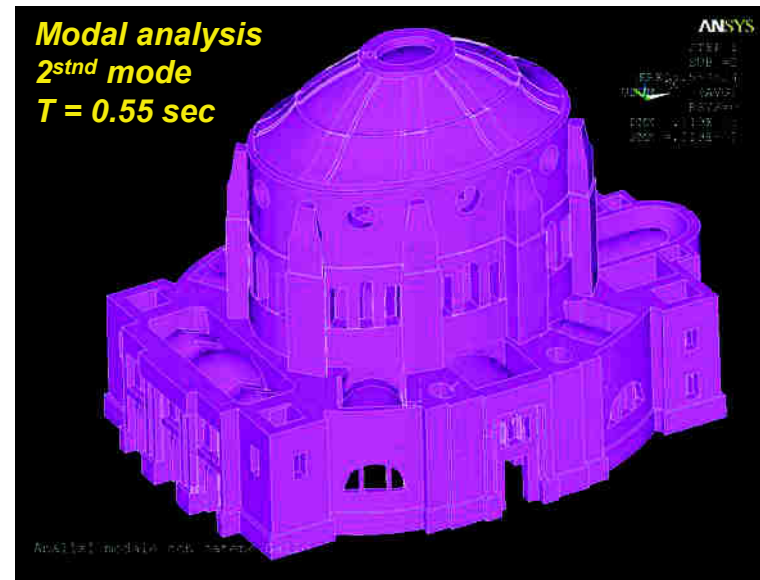
# 1. Linear-elastic FEM analysis of the entire undamaged building

Deformations

Stresses

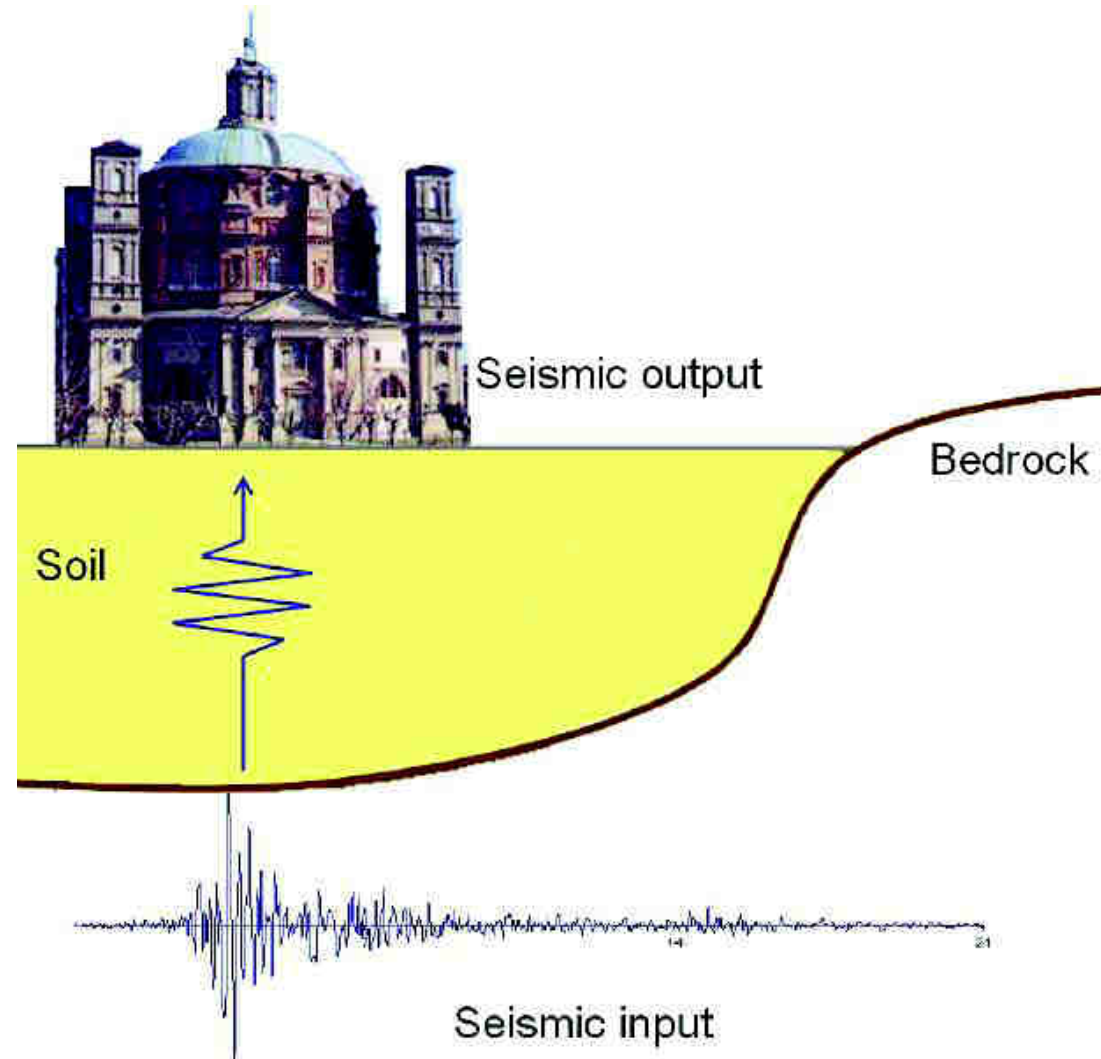
Influence of site conditions on the seismic response
